✓ LLOYDELL DAM

( ID NO. PA. 500 )

✓ PHASE I INSPECTION REPORT  
NATIONAL DAM INSPECTION PROGRAM

PHASE I REPORT  
NATIONAL DAM INSPECTION PROGRAM

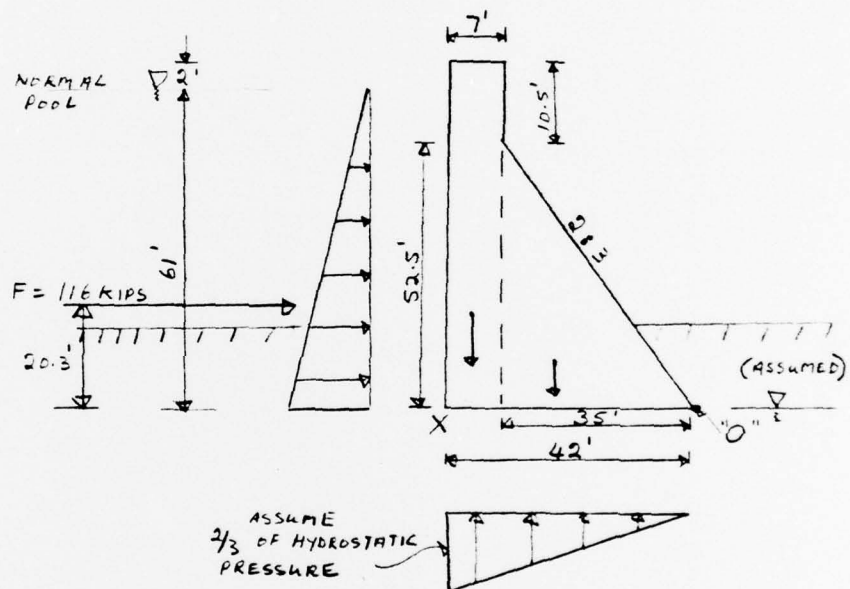
## STABILITY WITH RESPECT TO OVERTURNING — (NORMAL POOL)

$$\begin{aligned} \text{PRESSURE AT UPSTREAM END} &= \gamma h \\ &= 62.4 \times 61 = 3806 \text{ PSF} \\ &= 38 \text{ KSF} \end{aligned}$$

$$\text{TOTAL FORCE} = \frac{1}{2} (3806) \times 61 = \boxed{116 \text{ K/FT}}$$

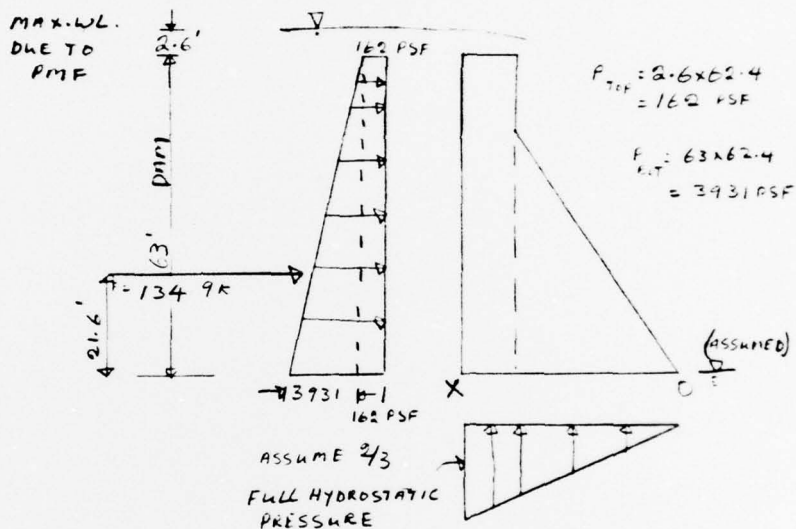
### 2.6' OVERTOPPING DUE TO PMF

$$TOTAL \text{ FORCE} = \frac{1}{2} (3931 \times 63) + 63 \times 162 = 134 \text{ KIPS}$$
